**HYDROFLUIDIC STABILITY AUGMENTATION SYSTEM (HYSAS)
OPERATIONAL SUITABILITY DEMONSTRATION**

Honeywell Inc.
1625 Zarthan Avenue
St. Louis Park, Minnesota 55416

October 1977

Final Report for Period March 1973 - March 1977

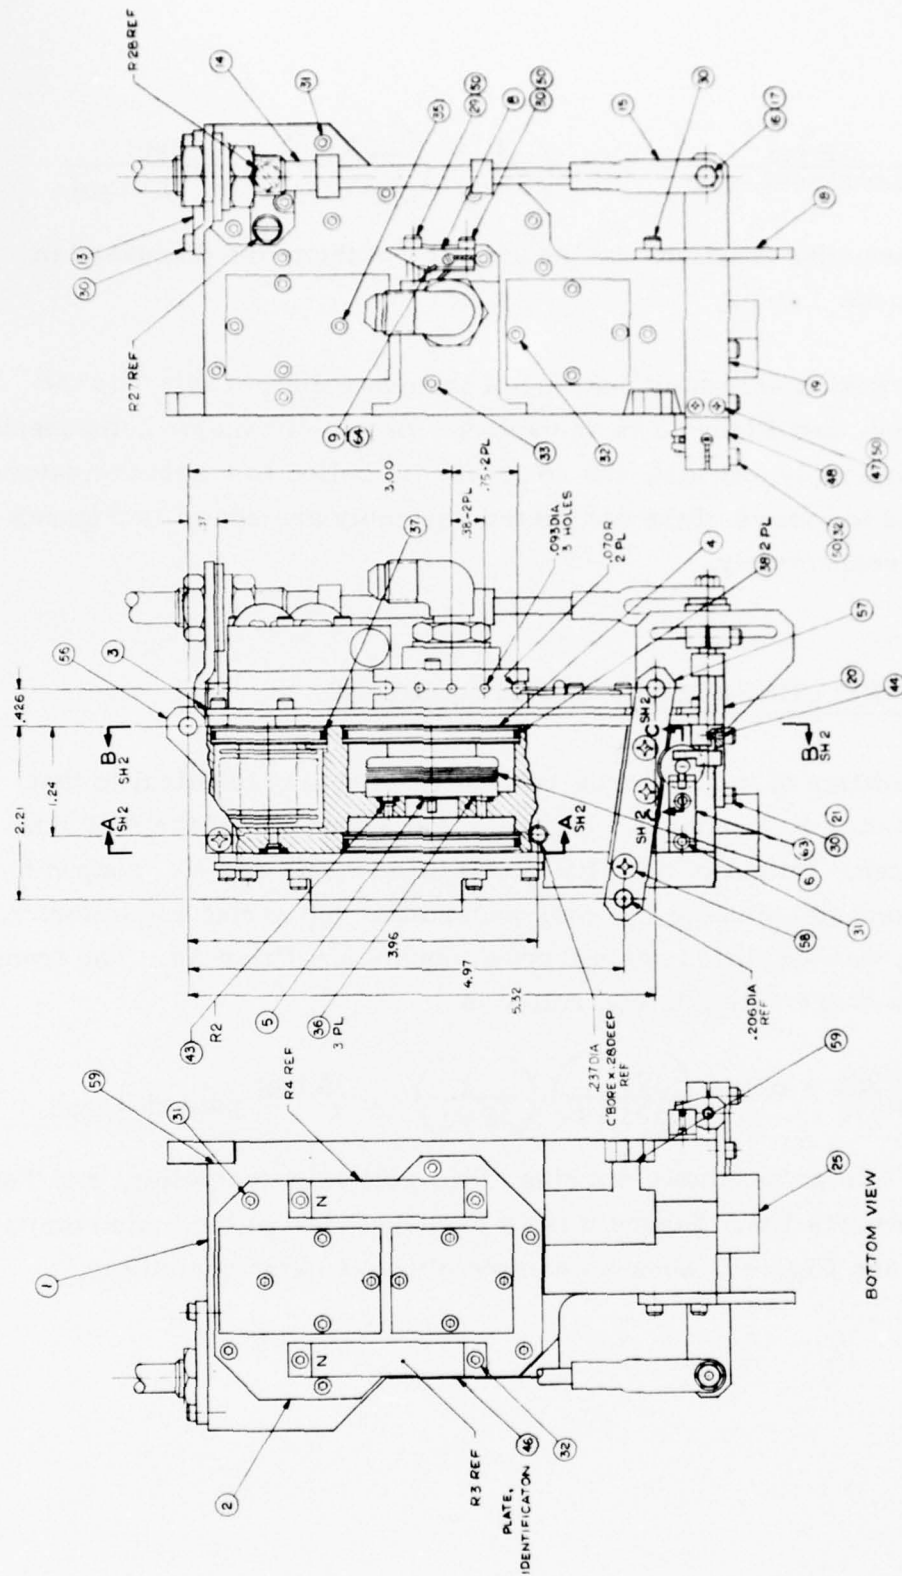
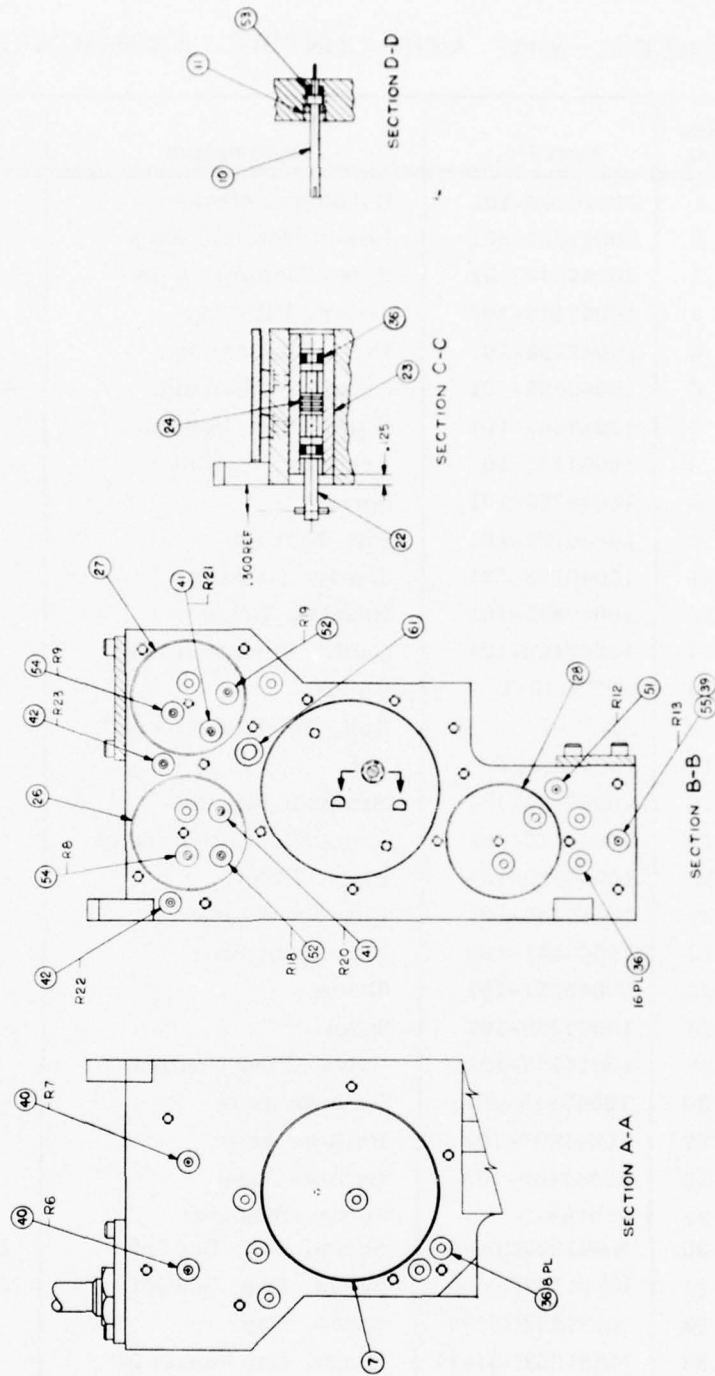
Figure 2. YG1143 Yaw Axis Controller Assembly Drawing.

PID leakage was the demonstrated or suspected cause of leakage in seven malfunctions: B02012, B02022, B02023, B02031, B02044, B02049, and B02052. A drawing of the PID spool and sleeve is designated as Section C-C in Figure 2, and the spool can also be seen in Figure 3. The spool seal design is identical to that designed on Contract DAAJ02-72-C-0051 (Reference 1). It proved to be satisfactory in laboratory tests and in flight tests. This design uses substantially less "O" ring compression than that of similar standard applications to reduce friction and to prevent damage to the "O" ring during assembly. If the compression were large, the "O" ring would extrude into the metering slot during assembly and this material would be sheared off as the "O" ring moved past the end of the slot. This would not only damage the "O" ring but it would also introduce contamination. A complete redesign will be required in future applications, and it must have the following features if a spool and sleeve configuration is selected.

BIT leakage was found during installation but was never experienced after the aircraft had completed its initial ground check. The BIT assembly is defined as Section D-D in Figure 2. The null adjust pin (No. 10 in Figure 2) and the "O" ring are retained by the locking sleeve (No. 11). This sleeve tends to work loose when BIT is depressed and released repeatedly (i. e., when the null adjust pin is rotated repeatedly). To correct the problem, this sleeve was permanently "staked" using a center punch on all units. This "staking" can be seen in Figure 34. All of the OH-58 units and some of the TH-57 units received this modification before they were shipped. The remaining TH-57 units were modified on site in Pensacola.

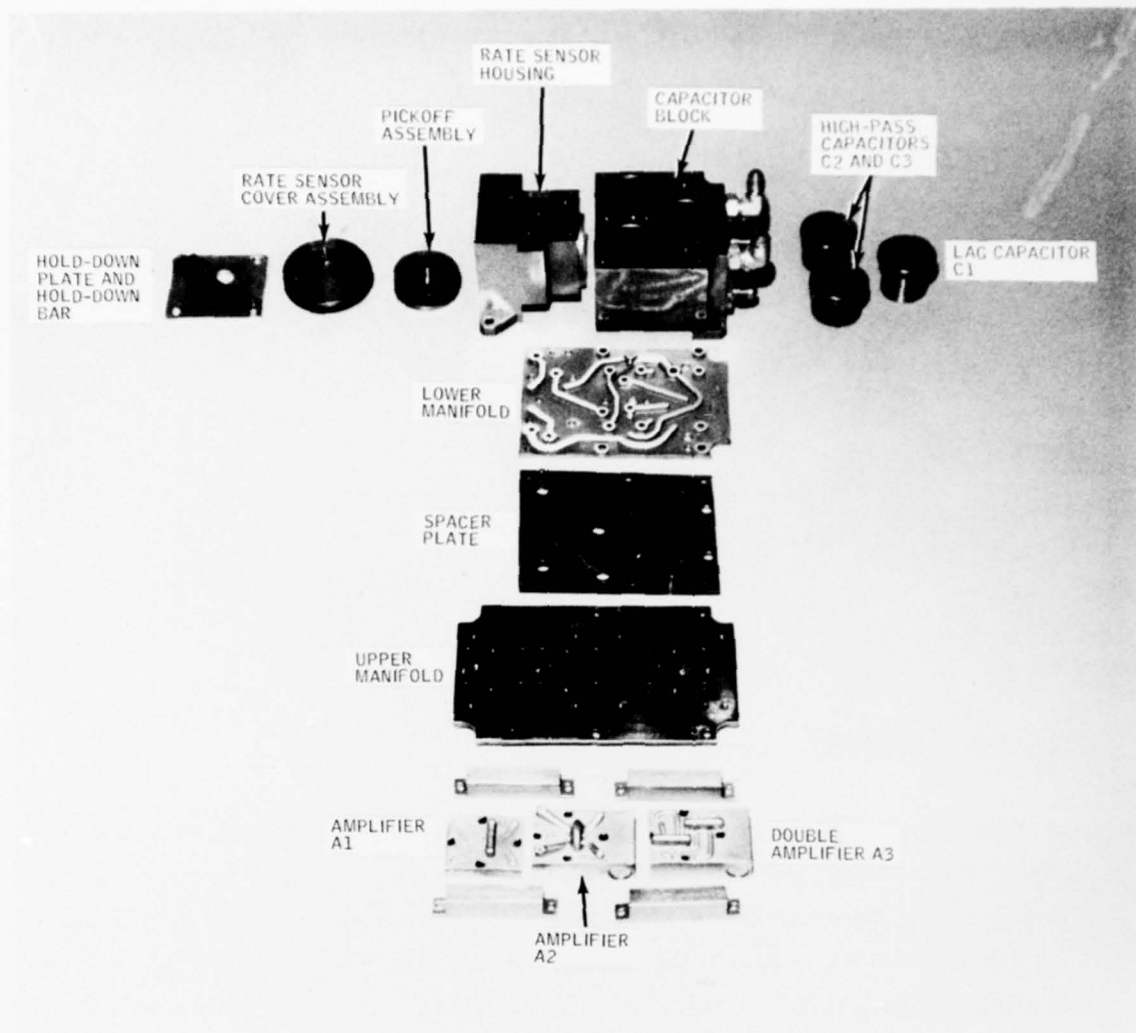
Figure 8. YG1136A - Roll Axis Controller Exploded View.

Proof pressure testing also showed that the hold-down clamps were not strong enough to contain the rate sensor covers; therefore, a stronger hold-down plate was designed (Figure 8). Stainless steel bolts used for holding down the manifolds were replaced with high-strength bolts to obtain the 900-psi proof pressure capability.

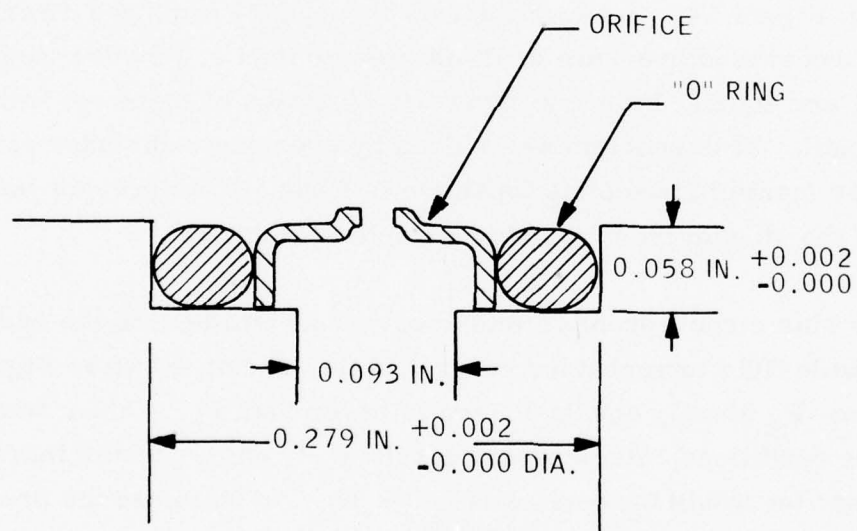
Figure 13. Sealing of Orifice Cup - Original Roll SAS.

reduce their effective diameter. Figure 12 shows a cross-sectional view of a typical junction between the upper and lower manifolds. One junction is required to have a 0.028-inch-diameter orifice, which is attached in the manner shown. A replaceable orifice cup cannot be used in this location because the height is insufficient to use the Figure 11 configuration and the standoff diameter is too small to use the Figure 13 configuration. These changes proved to be satisfactory.

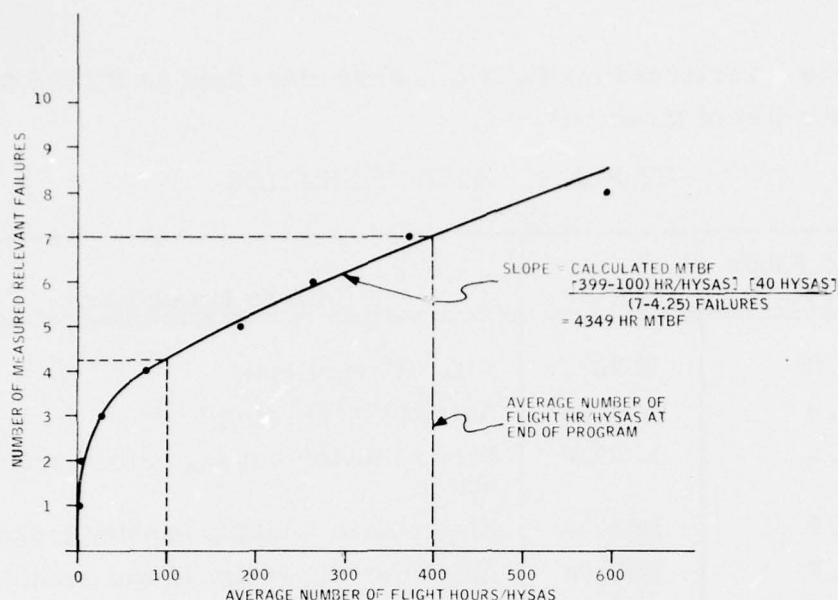
Figure 37. Field Measured MTBF Growth Curve.

Assuming that each future HYSAS receives a 100-hour MRI, the measured MTBF between this point on the growth curve and the 399-flight-hour point can be calculated by:

$$\begin{aligned}
 \text{MTBF (measured)} &= \frac{[(399-100) \text{ hr/HYSAS}] (40 \text{ HYSAS's})}{(7-4.25) \text{ Failures}} \\
 &= 4349 \text{ hrs MTBF}
 \end{aligned}$$

It should be noted that the 399-flight-hour point on the growth curve is the average number of flight hours that were accumulated on each HYSAS.
